**THE RESOURCES
OF THE
NEW ENGLAND-NEW YORK REGION**

HURRICANES

<u>Page</u>
SECTION XXXII - HURRICANES -	
INTRODUCTION -	1
Purpose. -	1
Scope. -	1
CHARACTERISTICS OF HURRICANES -	2
Definition. -	2
Origin. -	3
Hurricanes of the Western Hemisphere. -	5
Hurricane effects on large bodies of water. -	7
Hurricane effects on land. -	8
HISTORY OF HURRICANES -	9
HURRICANE OF SEPTEMBER 1938 -	17
General. -	17
Antecedent conditions. -	17
The Hurricane. -	18
Damages. -	19
Summary. -	24
HURRICANE OF SEPTEMBER 14-15, 1944 -	23
HURRICANES OF 1954 -	25
Hurricane Carol. -	25
Hurricane Edna. -	31
Hurricane Hazel. -	33
DAMAGES CAUSED BY 1954 HURRICANES -	35
General. -	35
Loss of life. -	36
Public property. -	37
Public buildings. -	38
Highways. -	38
Shore protective structures. -	39
Channel shoaling. -	40
Beach erosion. -	40
Works under construction. -	41
Estimates of damage. -	42
Shipping. -	42
Commercial vessels. -	44

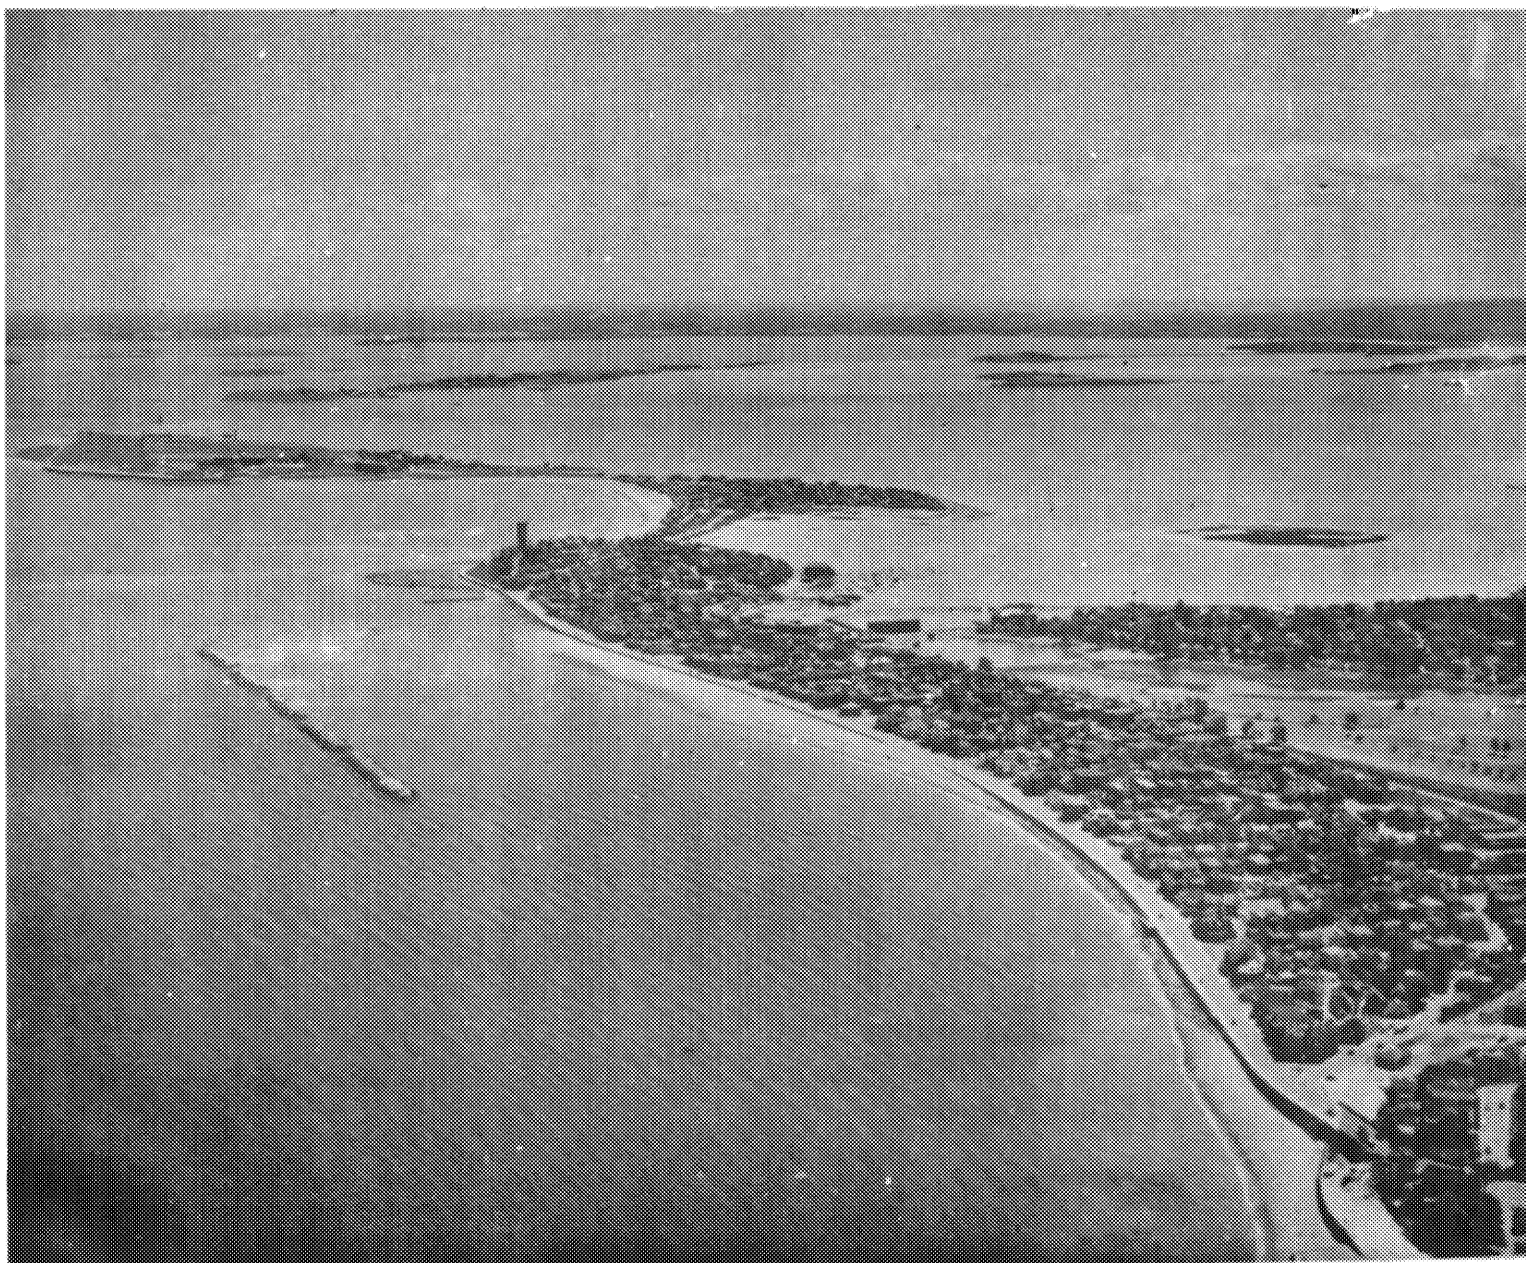
Offshore breakwater. Winthrop, Massachusetts. New England-New York Region.

(b) A stone-and-concrete breakwater may be either a rubble mound in which the voids are grouted with concrete, or a massive concrete superstructure on a rubble mound substructure. Both types tend to be relatively economical, especially in deep water, since relatively small quantities of material are needed. The rubble mound foundations must be protected from scour, and given time to settle before the concrete superstructure is added.
